## Structural Support During Environmental Cleanup – Clyde, Ontario

August 2005

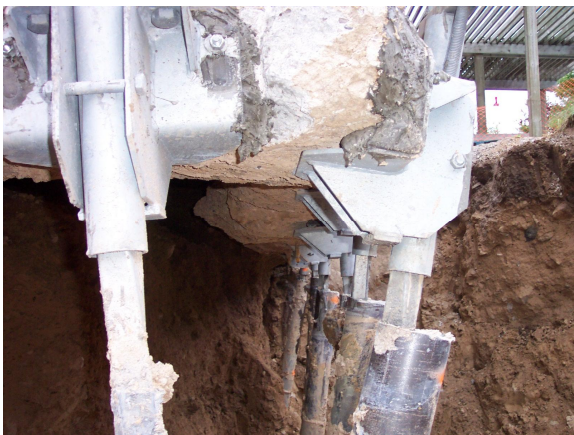
- Residential furnace oil tank leaked into soil below structures footings
- Structure needed to be either supported or removed during environmental cleanup
- Based on structure, caissons and driven piles were not a consideration due to the vibration caused during installation
- Depth of excavation below the structure footing to remove the impacted material was 2.7 m (9 ft)

- **Chance® Helical Piers** with foundation repair brackets were chosen to support the structure with some modifications
- The pier shaft was encased from the underside of the bracket to a calculated depth into the soil to be left undisturbed
- Encasement was a 150 mm (6") HSS steel section to provide the lateral support to the helical pier and provide bending resistance from eccentric load

- Steel pipe was filled with grout
- Once the helical piers were installed the impacted soil was removed and replaced with clean fill
- Chance Helical Piers were considerably more economical reparation method than other options presented to the client
