## Stabilization and Realignment of Townhomes – Sudbury, Ontario

October 2002

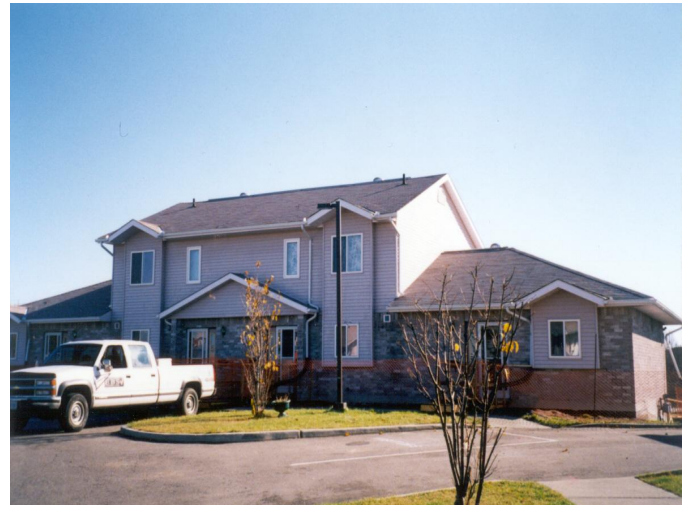
- Townhouse complexes consisting of one and two-storey units with foundations founded on a native compact, silty sand
- Two (2) townhouse complex footings were constructed below the existing high groundwater elevation
- Fines from the native soil underneath the footings washed into the weeping tile system, undermining the existing footings
- Settlement up to 250 mm (10 in.) occurred and the units were considered unstable and could no longer be occupied

- **Chance® Helical Pier®** was deemed the best repair system because it installs easily into soils with a high water table and there are no vibrations or spoils during installation
- Portable equipment could be used to install helical piers inside the basements of the units, and a small excavator fitted with an hydraulic power unit installed the piers on the exterior
- The lifting capabilities of the patented **Chance® Helical Pier® Foundation Repair Bracket** made it possible to raise the existing structure
- The **Chance® Helical Pier® Foundation System** was the most economical and least disruptive option to stabilize and realign these structures.
