## Structural Support During Environmental Cleanup – Clyde, Ontario

August 2005

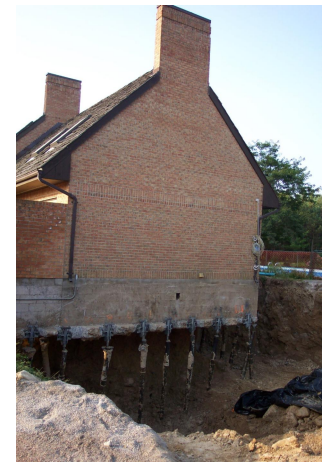
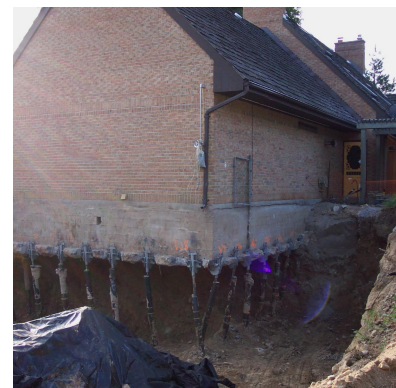
- Residential furnace oil tank leaked into soil below structures footings
- Structure needed to be either supported or removed during environmental cleanup
- Based on structure, caissons and driven piles were not a consideration due to the vibration caused during installation
- Depth of excavation below the structure footing to remove the impacted material was 2.7 m (9 ft)

- **Chance® Helical Piers** with foundation repair brackets were chosen to support the structure with some modifications
- The pier shaft was encased from the underside of the bracket to a calculated depth into the soil to be left undisturbed
- Encasement was a 150 mm (6") HSS steel section to provide the lateral support to the helical pier and provide bending resistance from eccentric load

- Steel pipe was filled with grout
- Once the helical piers were installed the impacted soil was removed and replaced with clean fill
- Chance Helical Piers were considerably more economical reparation method than other options presented to the client
