Chance® Helical Piers® used to Underpin Condominium – Toronto, ON

July 2009

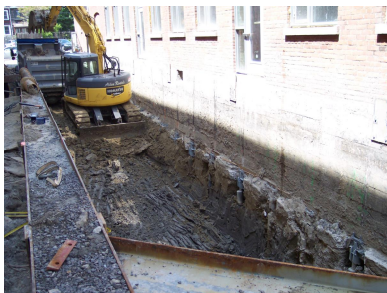
Piers installed – excavation beginning

- Chance® Helical Piers® were chosen for the project based on several reasons:
 - No vibration during installation
 - More cost effective solution than traditional technologies
- Helical pier shaft enclosed by a steel casing to provide lateral support once soil beneath foundation was removed (approximately 4.6 meters (15 feet) below underside of footings)

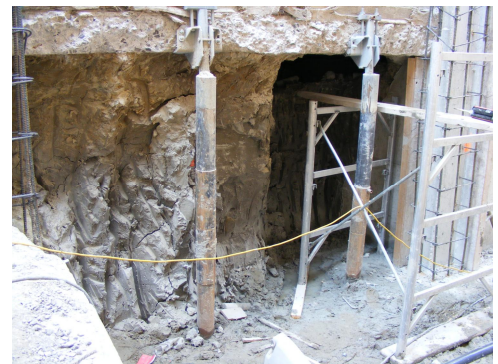
Sleeved helical piers during excavation operations

Product Used: (30) Chance® Helical Pulldown Micropiles® with 150 mm (6") diameter grout column inside steel casing
