## Residential Foundation Stabilization – Bolton, Ontario

September 1996

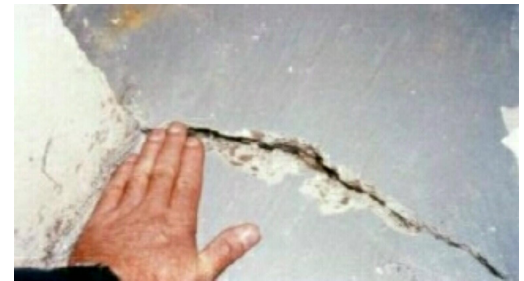
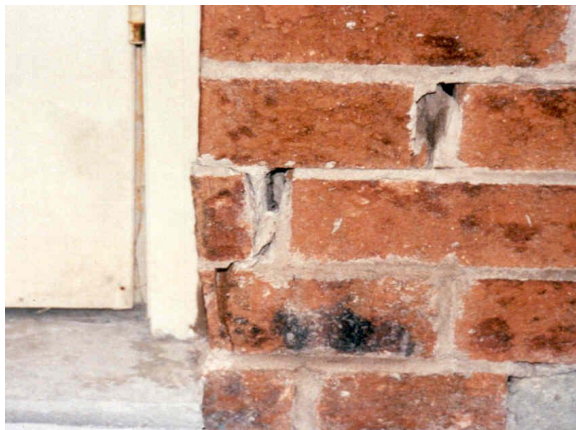
- Three residences constructed on a structural fill that had been placed to raise the grade on the lots that backed onto a wooden drainage ravine
- Structural fill placed over the native soil
- Fill placement ranged in depth below the foundation of 0 m at the front of the house to 1.8 m below the foundation at the rear of the house
- Homes were completed and cracking was first noticed three months later
- Based on the geometry and history of the cracks, it was determined that movement was occurring in the structures, both horizontally and vertically
- Investigation showed there was a soft fill zone at the rear of the residences

- Due to horizontal and vertical movement, both vertical and horizontal stabilization were necessary
- **Chance® Helical Piers** were the most economical and least disruptive option as the home owners were not required to move out during construction
